# Manhole Inspection Summary

Manhole # S06GG2006MH

Insp Date: **7/29/06 7:51 AM**

**Location** Address: **3505 WALLIS AVE**

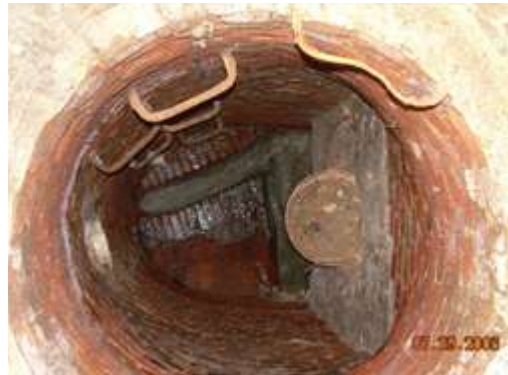
Top View

Adjustment and Corbel deterioration and infiltration. Barrel infiltration. Corroded steps. Bench debris.

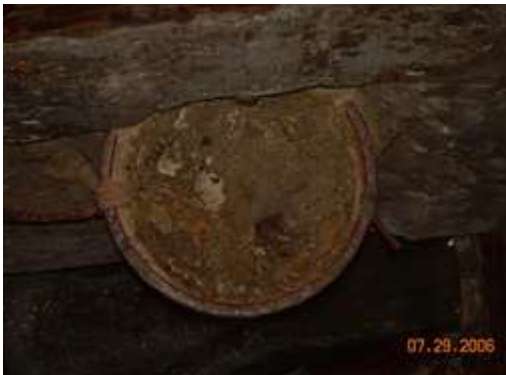
Plugged Storm Sewer line

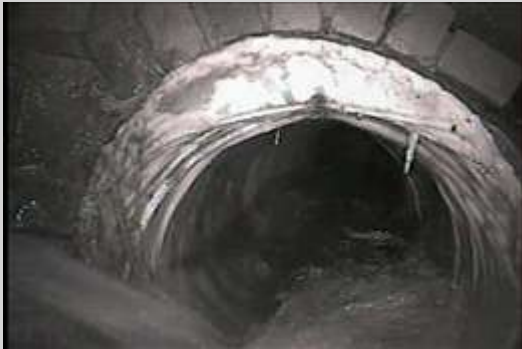
### 18 in. Circular Gravity Sewer Pipe Out @ 12 O'Clock

Barrel deterioration, root intrusion and infiltration.

Infiltration: **Evidence** Pipe Seal Cond: **Unknown**

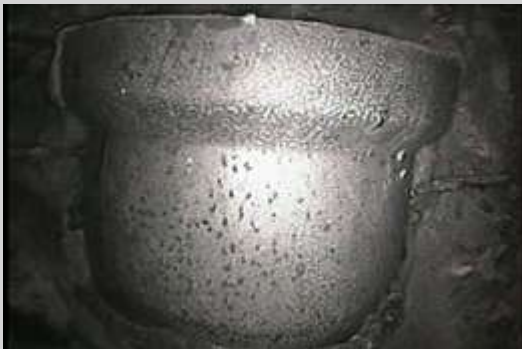
### 12 in. Circular Gravity Sewer Pipe In @ 3 O'Clock

Connects To: **Stub connection / abandoned**

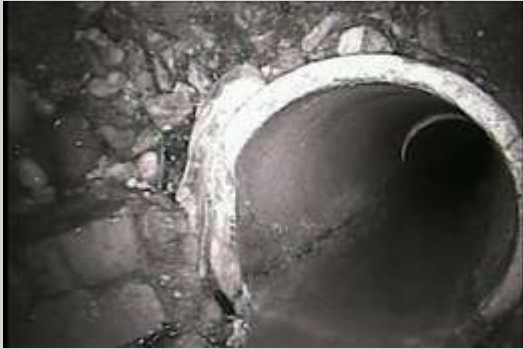
### 8 in. Circular Gravity Sewer

Barrel deterioration and infiltration. Channel deterioration.

Infiltration: **Evidence** Pipe Seal Cond: **Unknown**

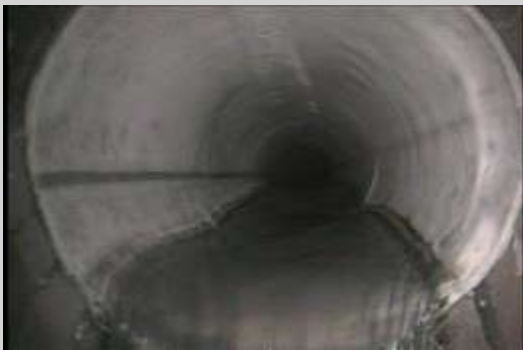
### 18 in. Circular Gravity Sewer

Infiltration: **Evidence** Pipe Seal Cond: **Roots**

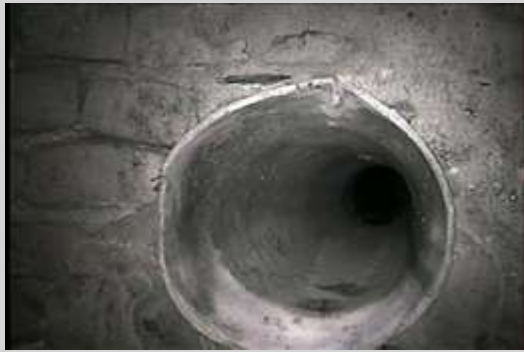
## 8 in. Circular Gravity Sewer

Barrel infiltration. Bench deterioration.

Infiltration: **Evidence** Pipe Seal Cond: **Unknown**

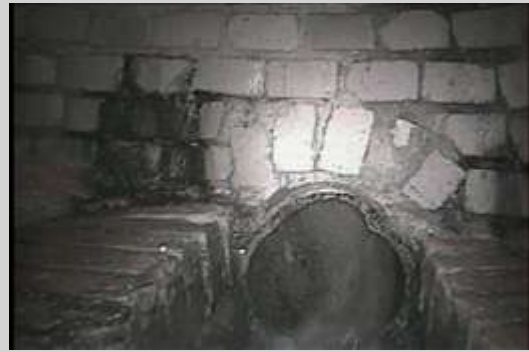
Drop In @ 9 O'Clock

Drop: **Outside** Rod and Bar

Drop Condition: **Open**
